GOT YOUR SIX NY HOME INSPECTIONS LLC

RESIDENTIAL ROOM-BY-ROOM INSPECTION

123 Main St.
Anywhere, NY 11111

08/06/2025

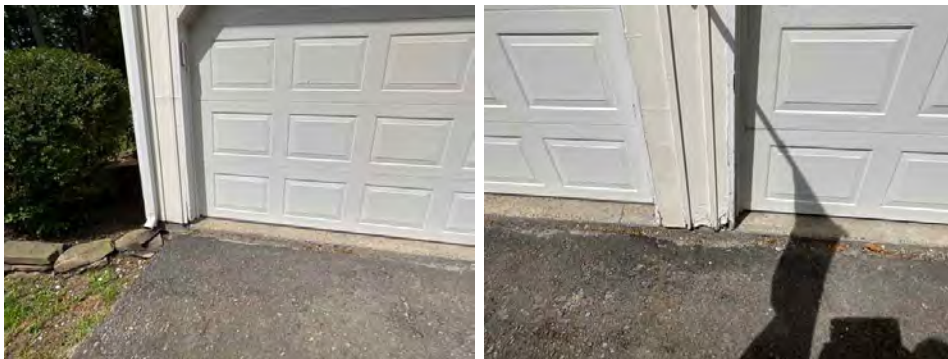
3.1.1 Driveway

CRACKING

Note cracking blacktop around garage door area.

recommend further inspection by qualified driveway contractor.

Contact a qualified driveway contractor.

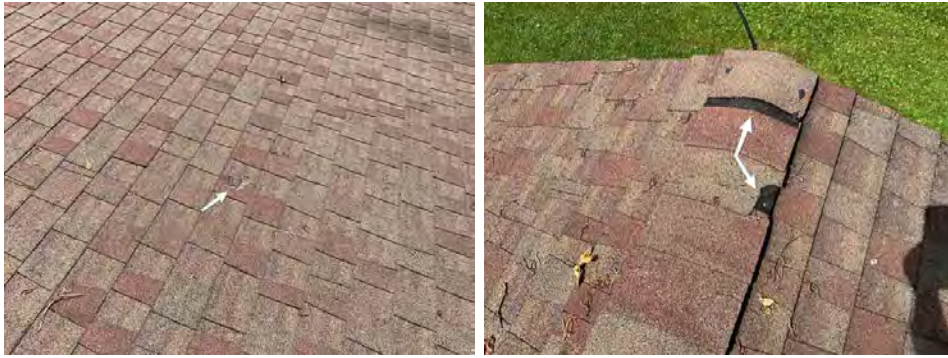
4.1.1 Coverings

TILES CRACKED/BROKEN

Roof had cracked/broken tiles. Recommend a qualified roof contractor repair or replace to prevent moisture intrusion and/or mold.

Contact a qualified roofing professional.

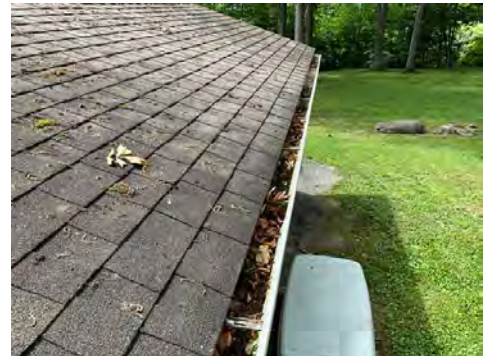
4.2.1 Roof Drainage Systems

DEBRIS

Debris has accumulated in the gutters. Recommend cleaning to facilitate water flow.

Contact a qualified roofing professional.

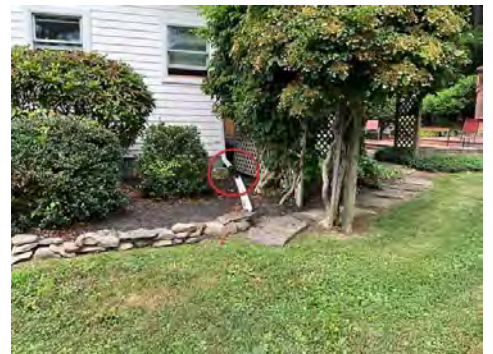
4.2.2 Roof Drainage Systems

DOWNSPOUTS DRAIN NEAR HOUSE

One or more downspouts drain too close to the home's foundation. This can result in excessive moisture in the soil at the foundation, which can lead to foundation/structural movement. Recommend a qualified contractor adjust downspout extensions to drain at least 6 feet from the foundation.

Gutter on east side of dwelling disconnected from downspout causing possible water and moisture intrusion close to foundation.

Contact a qualified gutter contractor

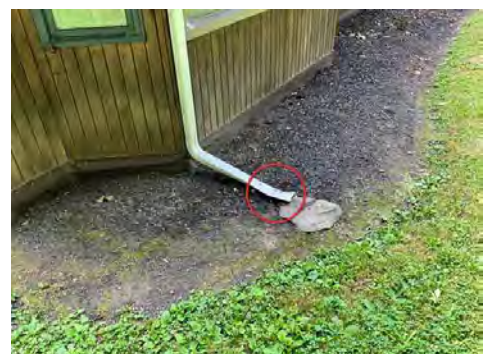
4.2.3 Roof Drainage Systems

GUTTER DAMAGED

Gutters were damaged. This can result in excessive moisture in the soil at the foundation, which can lead to foundation/structural movement. Recommend a qualified contractor evaluate and repair.

Contact a qualified gutter contractor

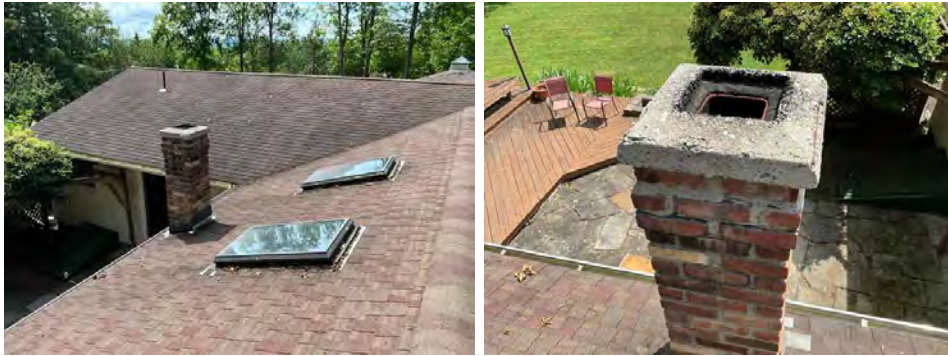
4.4.1 Skylights, Chimneys & Other Roof Penetrations

CHIMNEY CAP MISSING

No chimney cap was observed. This is important to protect from moisture intrusion and protect the chimney. Recommend a qualified roofer or chimney expert install.

Contact a qualified roofing professional.

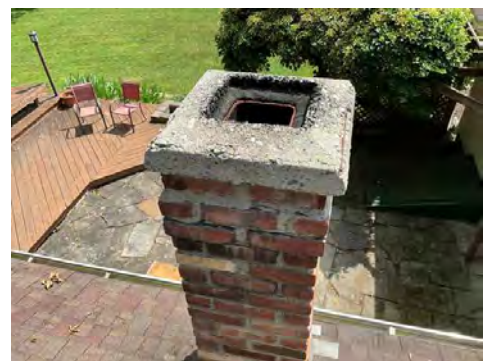
4.4.2 Skylights, Chimneys & Other Roof Penetrations

CHIMNEY REPOINT NEEDED

Joints in the masonry have deteriorated and should be repointed. (Repointing is the restoration of the mortar joints in the masonry).

East side chimney of dwelling.

Contact a qualified chimney contractor.

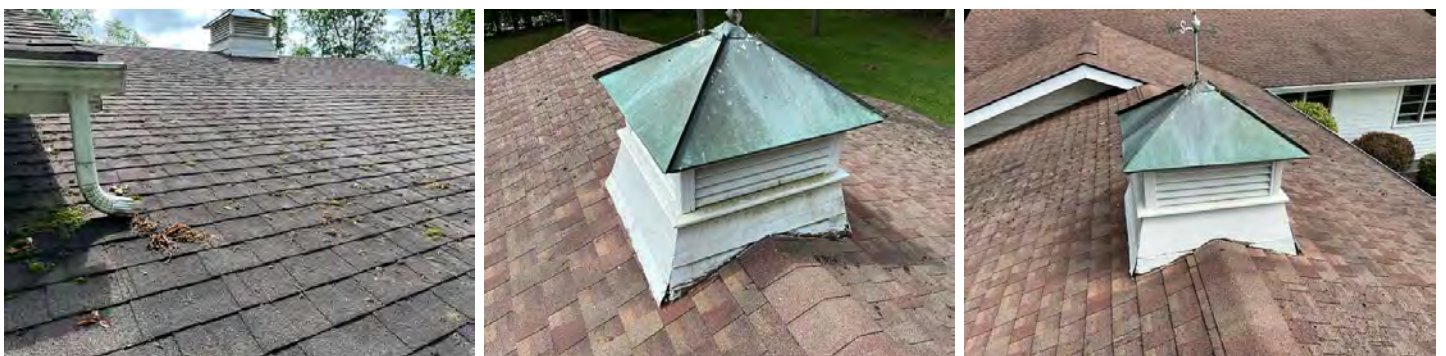
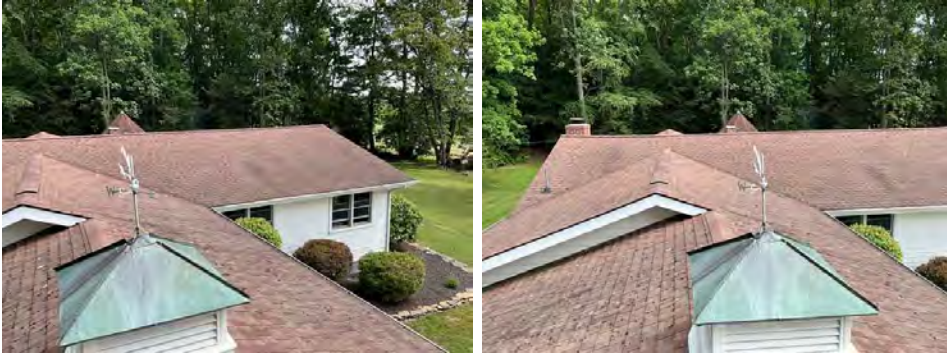
4.4.3 Skylights, Chimneys & Other Roof Penetrations

RIDGE TOWER / WEATHERVANE

Wood trim at base of rooftop structure beginning to show signs of rotting. Recommend further inspection and repair by qualified roofing contractor.

Contact a qualified roofing professional.

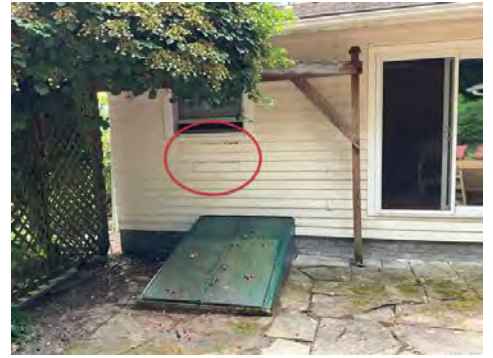
5.2.1 Siding, Flashing & Trim

CRACKING - MINOR

Siding showed cracking in one or more places. Possibly due to previous repair from window replacement (per conversation with owner).

Contact a qualified siding specialist.

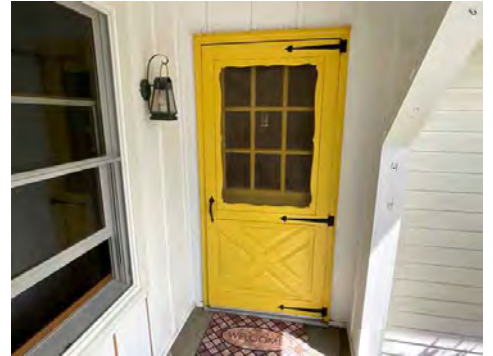
5.3.1 Exterior Doors

WEATHERSTRIPPING NOT PRESENT

Door is missing standard weatherstripping. This can result in significant energy loss and moisture intrusion. Recommend installation of standard weatherstripping.

Contact a qualified door repair/installation contractor.

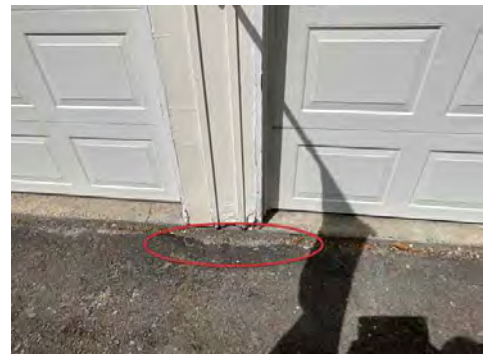
5.4.1 Walkways, Patios & Driveways

DRIVEWAY CRACKING - MINOR

Minor cosmetic cracks observed, which may indicate movement in the soil. Recommend monitor and/or have concrete contractor patch/seal.

Contact a qualified driveway contractor.

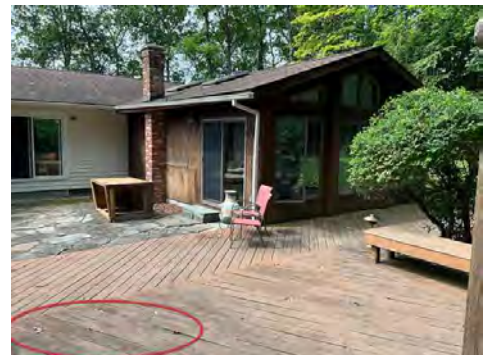
5.5.1 Decks, Balconies, Porches & Steps

DECK - WATER SEALANT REQUIRED

Deck is showing signs of weathering and/or water damage. Recommend water sealant/weatherproofing be applied.

Recommended DIY Project

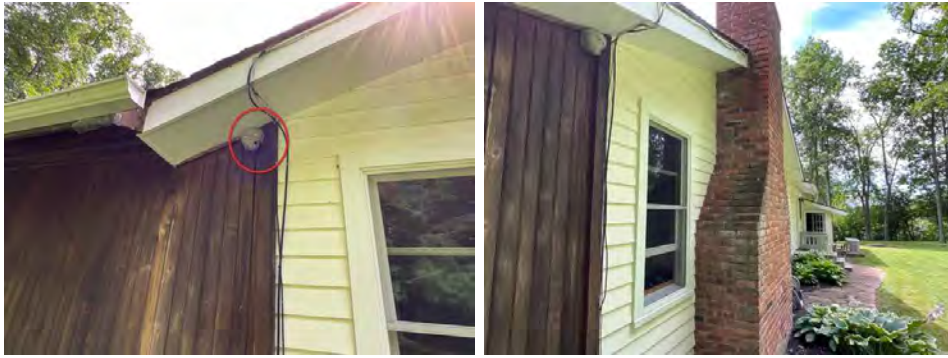
5.6.1 Eaves, Soffits & Fascia

WASPS NEST

Wasp nests were visible under the soffits. Recommend a qualified exterminator evaluate and remove.

Contact a qualified pest control specialist.

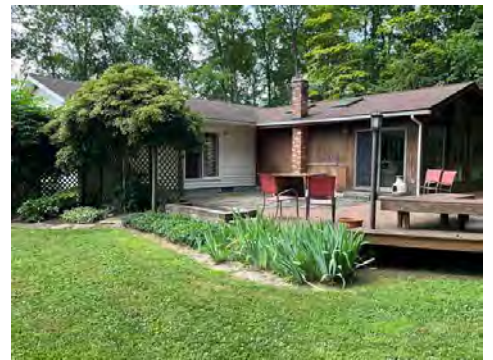
5.7.1 Vegetation, Grading, Drainage & Retaining Walls

TREE OVERHANG

Trees observed overhanging the roof. This can cause damage to the roof and prevent proper drainage. Recommend a qualified tree service trim to allow for proper drainage.

Recommended DIY Project

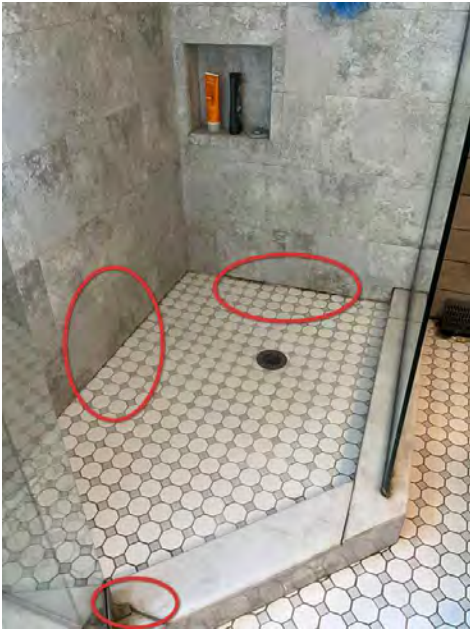
10.2.1 Shower

CORROSION, MILDEW

Note presence of mildew at base of shower stall.

Recommended DIY Project

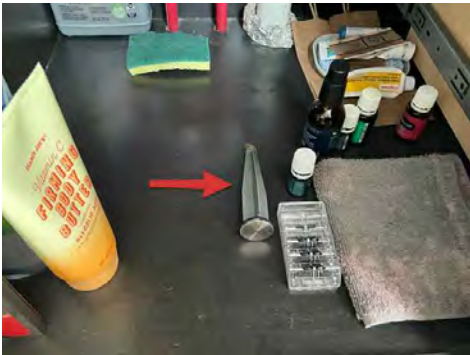
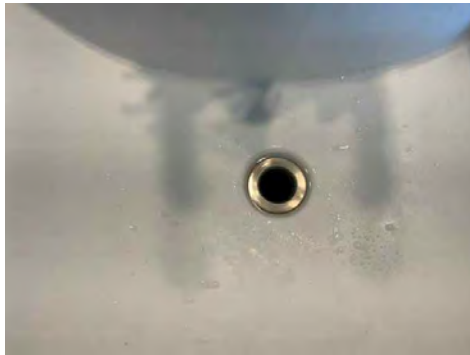
10.4.1 Water Supply, Distribution Systems & Fixtures

Repair Needed**MISCELLANEOUS**

Bathroom sink drain stopper is removed from sink. Conversation with owner revealed stopper corroded and inoperative. owner removed.

Contact a qualified plumbing contractor.

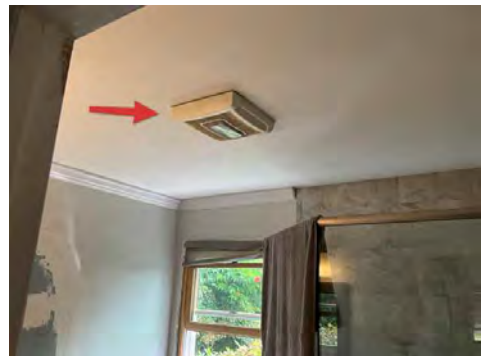
10.5.1 Lighting Fixtures, Switches & Receptacles

Maintenance Item**LIGHT INOPERABLE**

One or more lights are not operating. New light bulb possibly needed.

Contact a qualified electrical contractor.

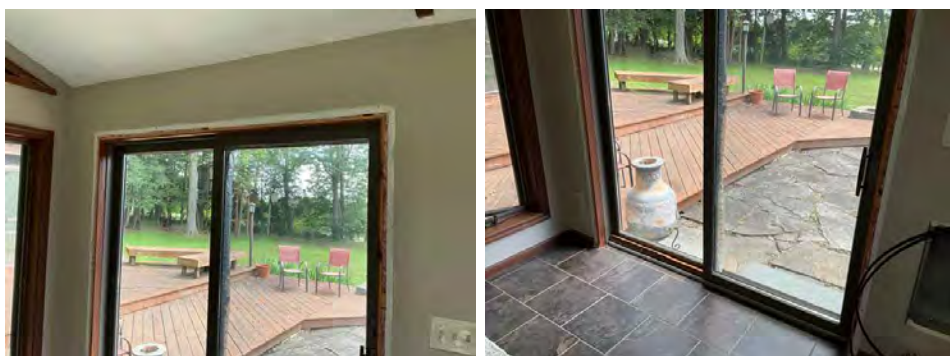
11.1.1 Doors

POOR WEATHER-STRIPPING

At the time of the inspection, weather-stripping at interior doors was generally damaged or deteriorated. The Inspector recommends replacement/installation of effective weather-stripping components as necessary by a qualified contractor.

Contact a qualified handyman.

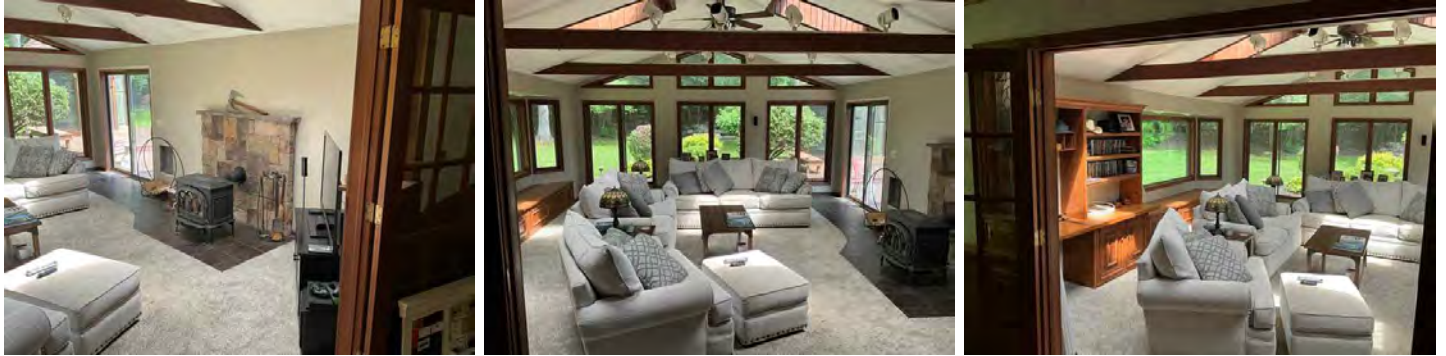
11.3.1 Floors

CARPET STAINS

Carpet had areas of staining or discoloration. Recommend a thorough steam clean by a qualified carpet cleaning company

Contact a qualified cleaning service.

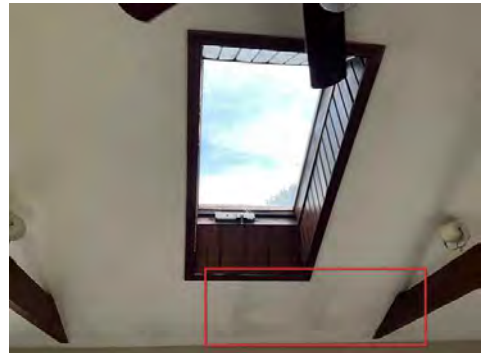
11.5.1 Ceilings

STAIN(S) ON CEILING

There is a stain on ceiling/wall that requires repair and paint. Source of staining should be determined.

Contact a qualified painting contractor.

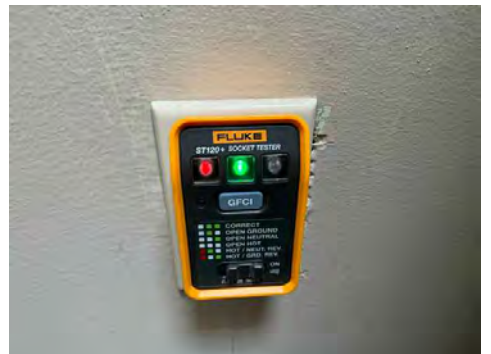
11.8.1 GFCI & AFCI

IMPROPER INSTALLATION

HOT / neutral polarity reversed at one outlet receptacle in living room. Recommend further inspection and repair by qualified electrical contractor.

Contact a qualified electrical contractor.

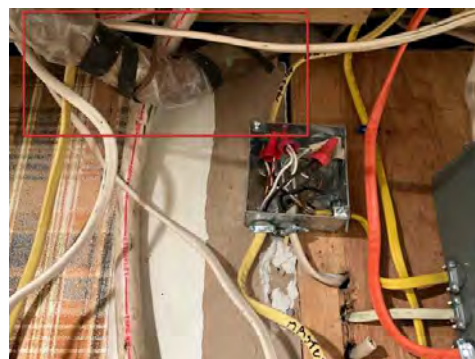
13.3.1 Drain, Waste, & Vent Systems

SINK - POOR DRAINAGE

Kitchen sink had slow/poor drainage.

Verify kitchen sink drain pipe routed directly overhead of Main Electrical panel. inadequate patching of drain pipe possibly causing slow drainage issues with kitchen sink.

Note: plumbing drain routed in close proximity to exposed electrical junction box.

Contact a qualified plumbing contractor.
