# GOT YOUR SIX NY HOME INSPECTIONS LLC

## GOT YOUR SIX NY HOME INSPECTION LLC

456 Main St  
Albion, NY 11111

07/18/2025

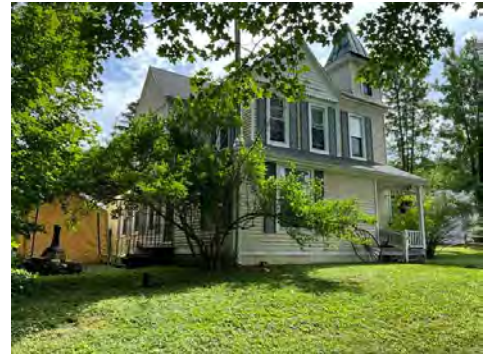
### 3.2.1 Roof Drainage Systems

#### DOWNSPOUTS DRAIN NEAR HOUSE

One or more downspouts drain too close to the home's foundation. This can result in excessive moisture in the soil at the foundation, which can lead to foundation/structural movement. Recommend a qualified contractor adjust downspout extensions to drain at least 6 feet from the foundation.

Contact a qualified roofing professional.

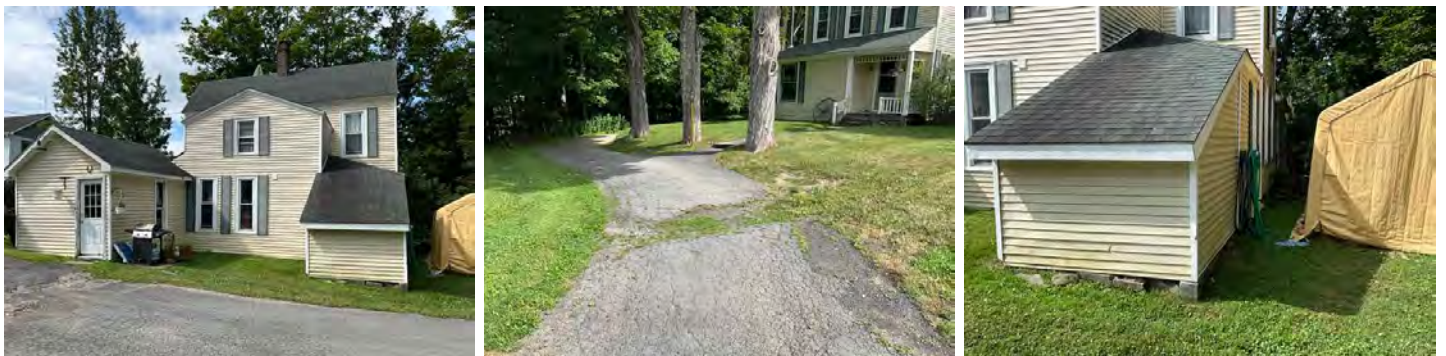
### 3.2.2 Roof Drainage Systems

#### GUTTERS MISSING

There are no gutters present on the structure. Gutters are recommended because they collect rain water from the roof and direct it away from the building.

Contact a qualified gutter contractor

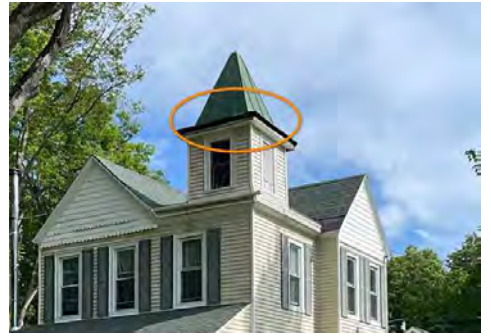
### 3.3.1 Flashings

#### **LOOSE/SEPARATED**

Flashings observed to be loose or separated, which can lead to water intrusion and/or mold. Recommend a qualified roofing contractor repair.

Contact a qualified roofing professional.

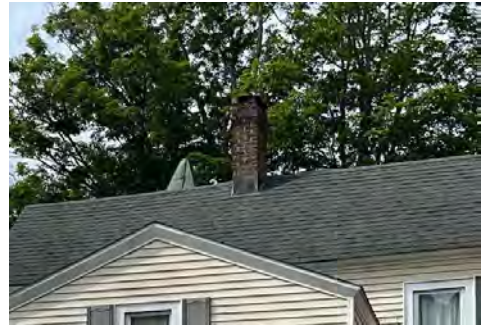
### 3.4.1 Skylights, Chimneys & Other Roof Penetrations

#### **CHIMNEY REPOINT NEEDED**

Joints in the masonry have deteriorated and should be repointed. (Repointing is the restoration of the mortar joints in the masonry).

Contact a qualified chimney contractor.

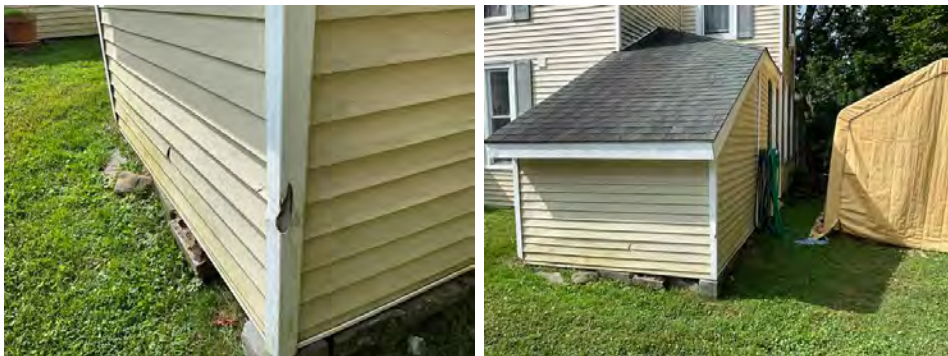
### 4.1.1 Foundation

#### **WALL(S) BOWING/LEANING**

Foundation wall is bowing and/or leaning. Repair of wall is recommended.

Contact a qualified structural engineer.

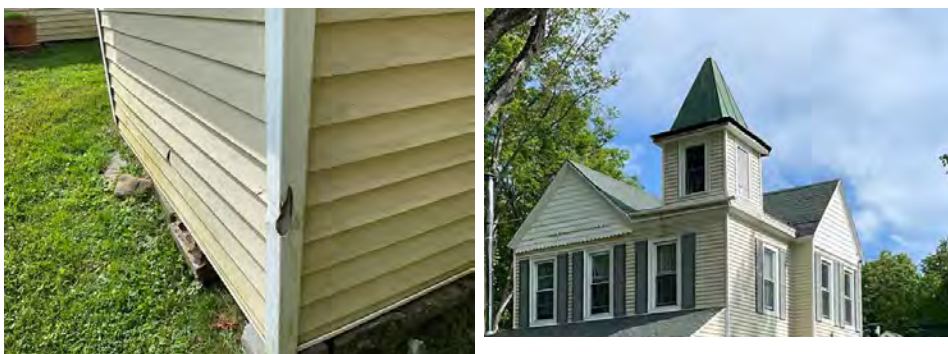
### 4.2.1 Siding, Flashing & Trim

#### **CRACKING - MINOR**

Siding showed cracking in one or more places. This is a result of temperature changes, and typical as homes with stucco age. Recommend monitoring.

Contact a qualified siding specialist.

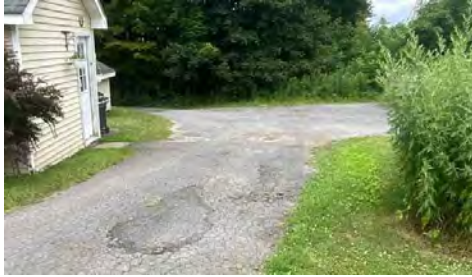
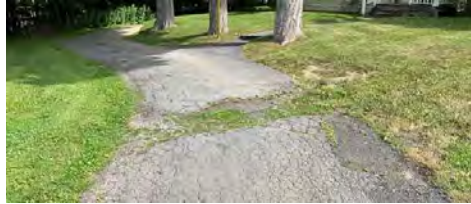
#### 4.4.1 Walkways, Patios & Driveways

### DRIVEWAY CRACKING - MAJOR

Major cracks observed. Recommend concrete contractor evaluate and replace.

Contact a qualified concrete contractor.

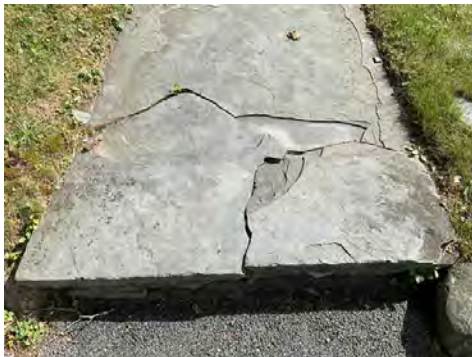
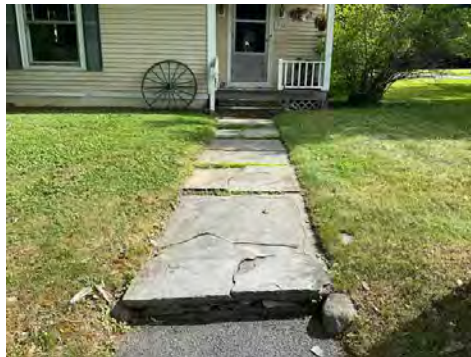
#### 4.4.2 Walkways, Patios & Driveways

### WALKWAY CRACKING - MINOR

Minor cosmetic cracks observed. Recommend monitor and/or patch/seal.

Recommended DIY Project

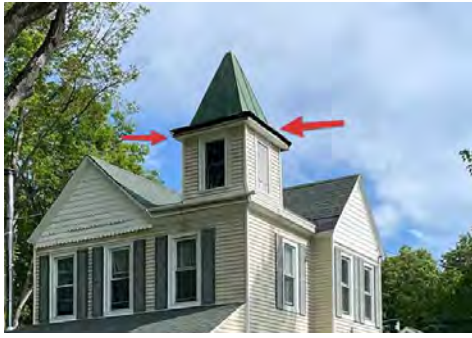
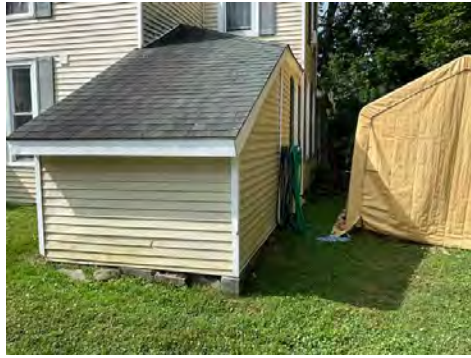
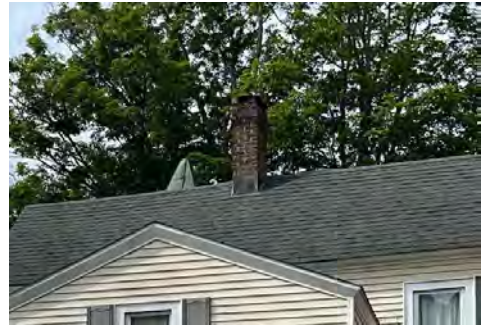
#### 4.5.1 Eaves, Soffits & Fascia

### EAVES - DAMAGED

One or more sections of the eaves are damaged. Recommend qualified roofer evaluate & repair.

Contact a qualified roofing professional.

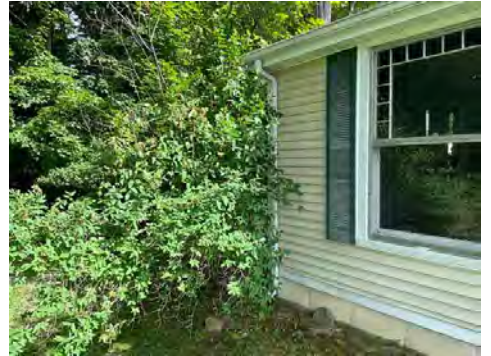
#### 4.6.1 Vegetation, Grading, Drainage & Retaining Walls

### TREE OVERHANG

Trees observed overhanging the roof. This can cause damage to the roof and prevent proper drainage. Recommend a qualified tree service trim to allow for proper drainage.

Contact a qualified tree service company.

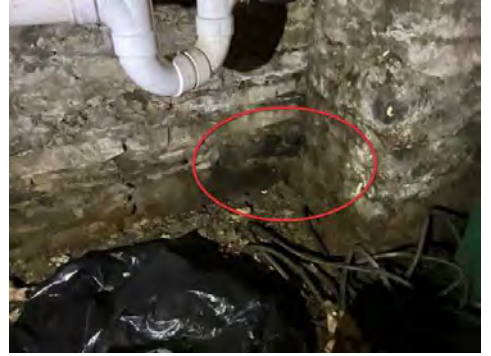
### 5.2.1 Floor Structure

#### EVIDENCE OF WATER INTRUSION

There were signs of water intrusion in the underlying floor structure. Recommend identifying source of moisture and repairing.

Contact a foundation contractor.

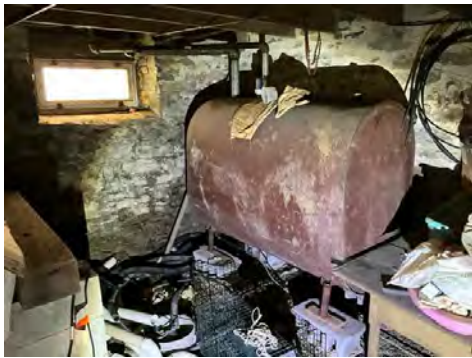
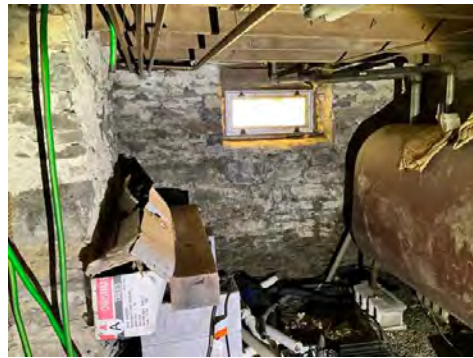
### 5.5.1 Sump Pump

#### NEEDS CLEANING

Sump pump was excessively dirty and in need of cleaning/servicing.

Contact a qualified plumbing contractor.

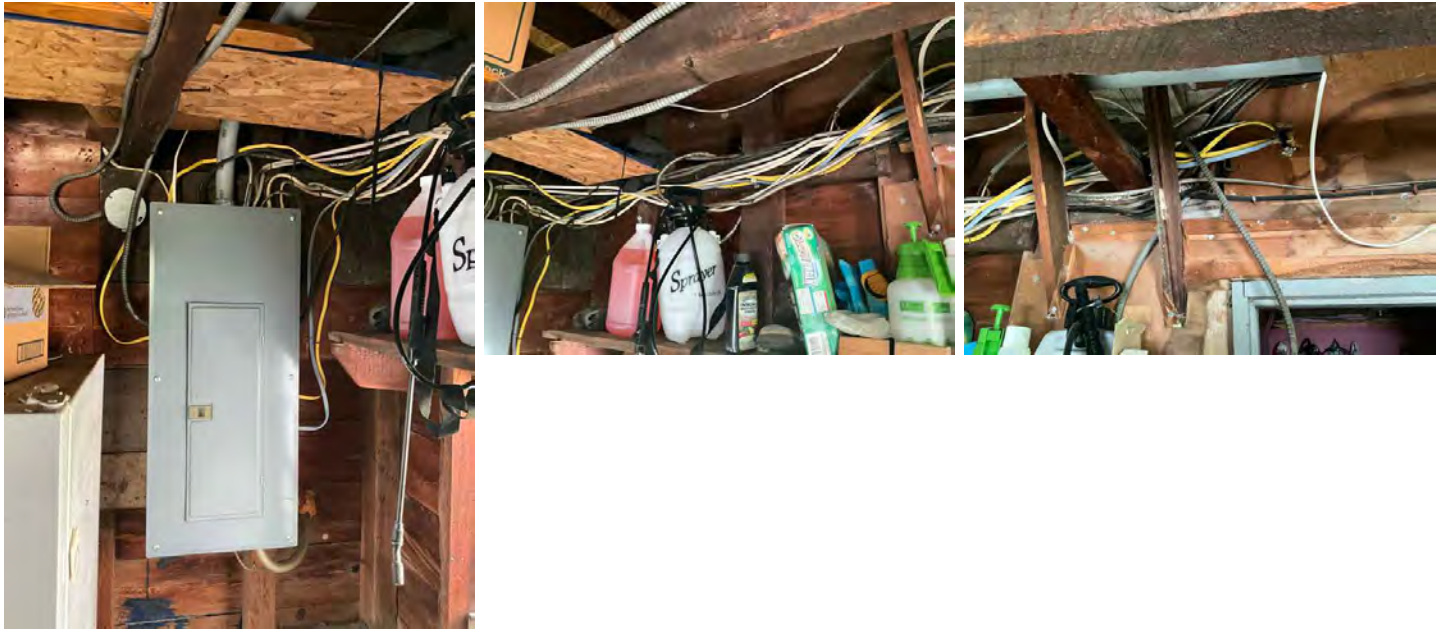
### 6.3.1 Branch Wiring Circuits, Breakers & Fuses

#### **INADEQUATELY SECURED , ROUTED / LOOSE WIRING**

MUD ROOM

Conduit wiring not evenly secured around breaker panel and throughout initial routing.

Contact a qualified electrical contractor.

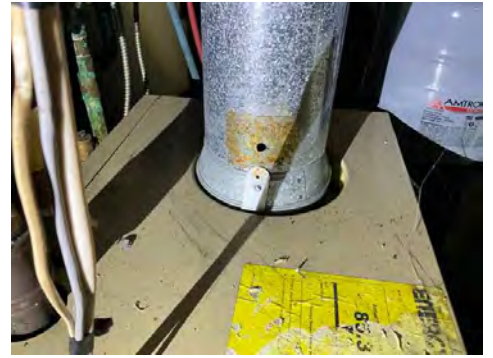
#### 7.1.2 General

**RUSTED / ROTTED**

BASEMENT

Note hole in exhaust pipe to chimney. Recommend further inspection and evaluation from qualified heating / cooling contractor.

Contact a qualified heating and cooling contractor

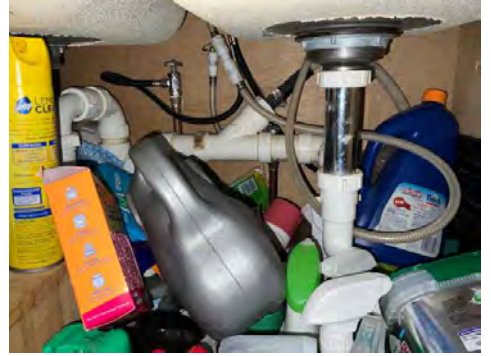
## 9.4.1 Sink

**OBSTRUCTIONS**

Observed various cleaning bottles and containers under kitchen sink vanity cabinet which could inhibit use of faucet spray nozzle as well as interfere with hot / cold supply lines causing premature or unwanted damage or leaks.

Always be sure to keep stored items away from under sink plumbing hoses and fixture to prevent any issues.

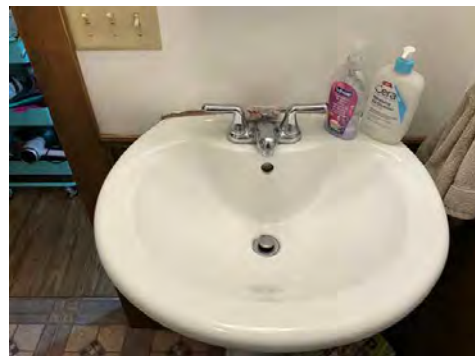
10.3.1 Sink / Vanity

### MOUNTING

Sink loosely mounted to wall. Caulking behind sink mildew stained and peeling.

Contact a qualified plumbing contractor.

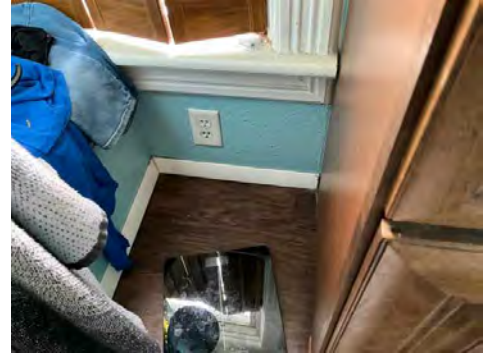
### 11.4.1 GFCI & AFCI

#### NO GFCI PROTECTION INSTALLED

No GFCI protection present in all locations. Recommend licensed electrician upgrade by installing ground fault receptacles in all locations.

Contact a qualified electrical contractor.

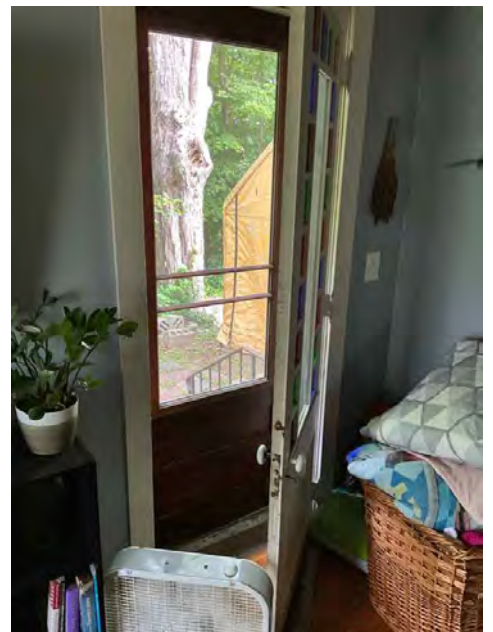
### 12.1.1 Doors

#### POOR WEATHER-STRIPPING

At the time of the inspection, weather-stripping at interior doors was generally damaged or deteriorated. The Inspector recommends replacement/installation of effective weather-stripping components as necessary by a qualified contractor.

Contact a qualified handyman.

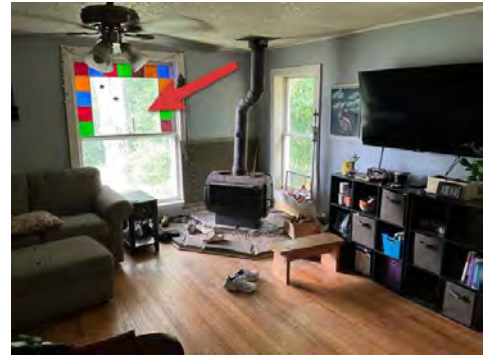
### 12.2.1 Windows

#### PAINTED SHUT

One or more windows are painted shut. Recommend windows be restored to functional use.

Contact a qualified window repair/installation contractor.

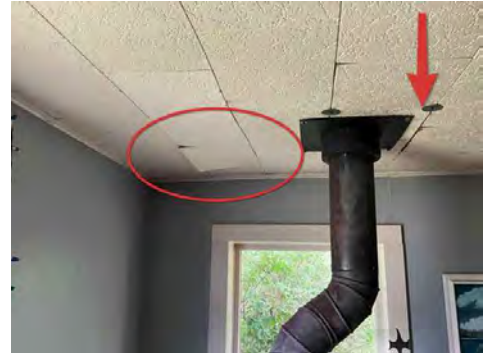
#### 12.5.1 Ceilings

### MINOR DAMAGE

Minor damage or deterioration to the ceiling was visible at the time of the inspection.

Contact a qualified professional.
