GOT YOUR SIX NY HOME INSPECTIONS LLC

RESIDENTIAL ROOM-BY-ROOM INSPECTION

1234 Main Street
Greenville, NY 12083

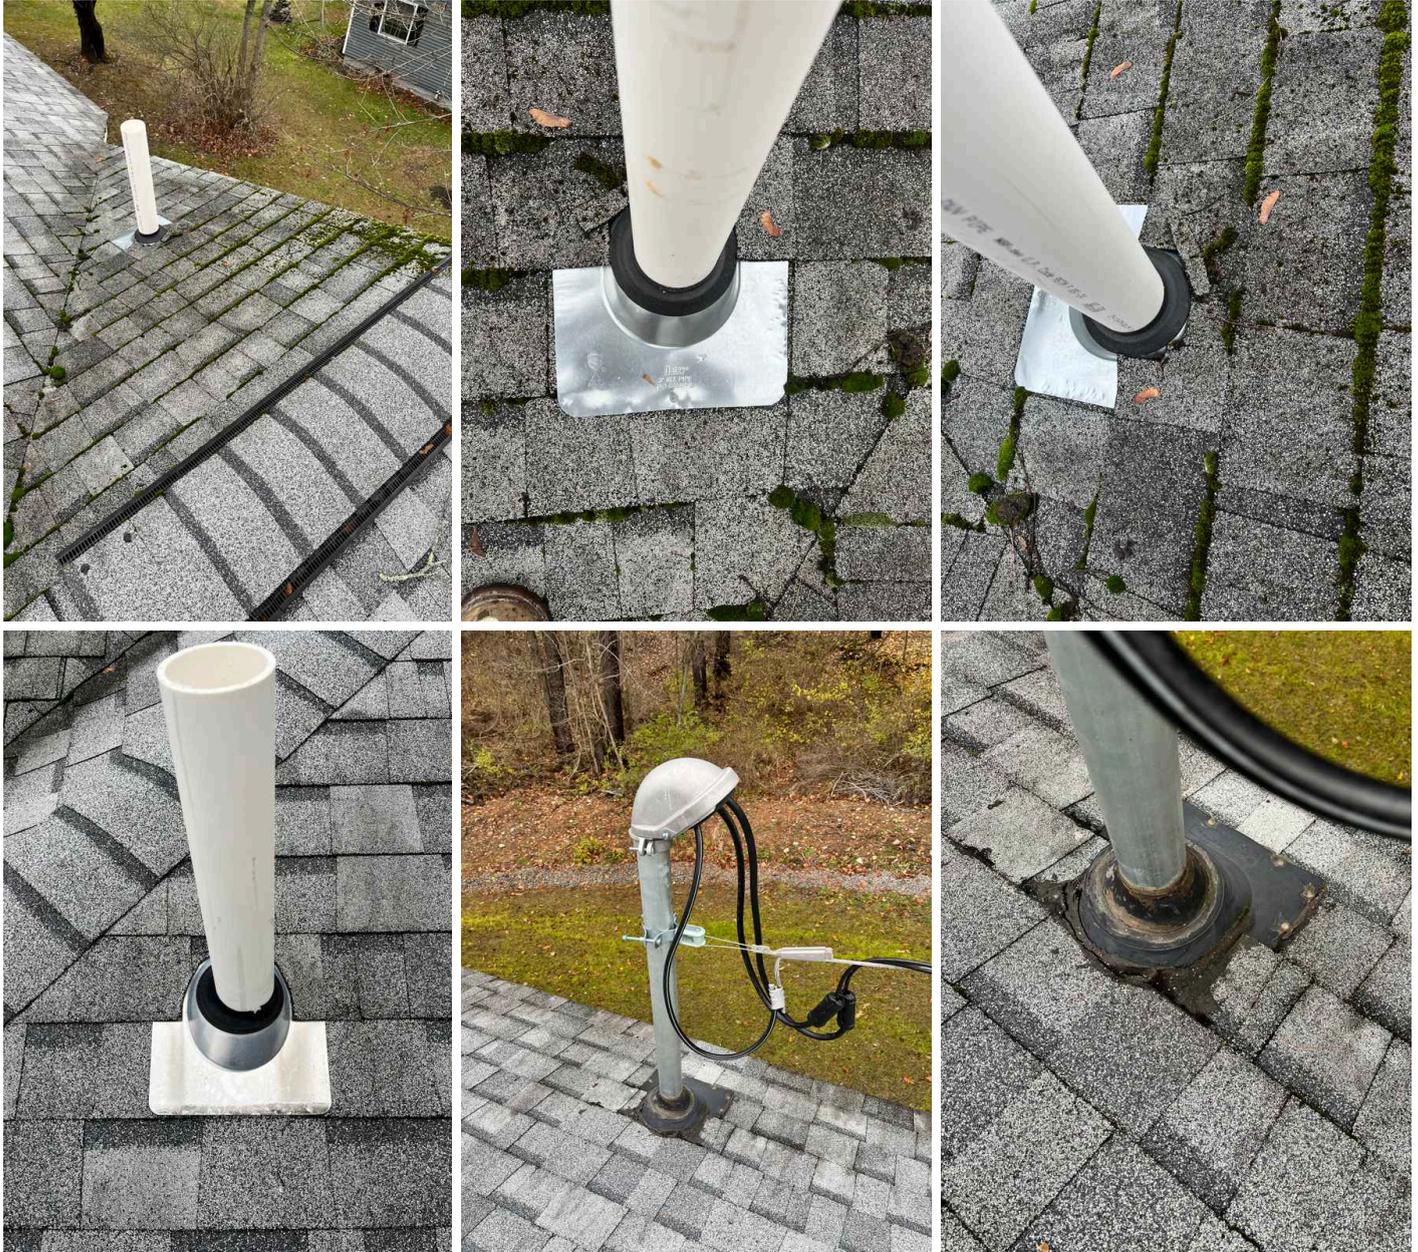
Note presence (2) PVC drain-waste vent pipes protruding from roofline. Verify 3" vents installed. No defects noted at this time.

Also note electrical service supply entrance mast and weatherhead. (Service -Drop). No defects noted.

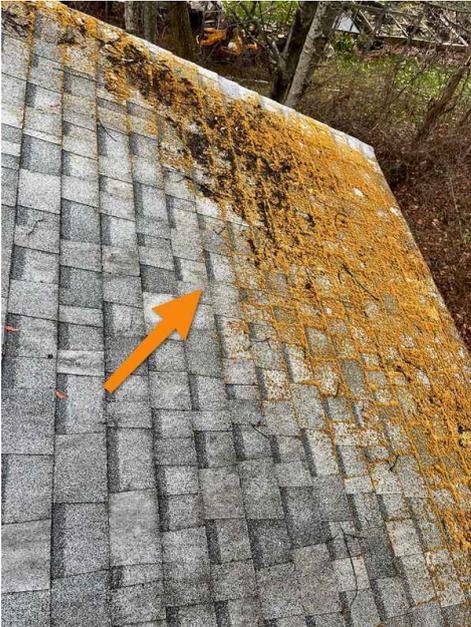
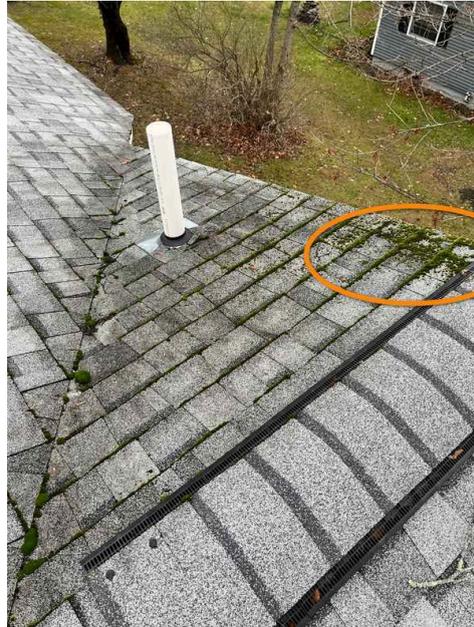
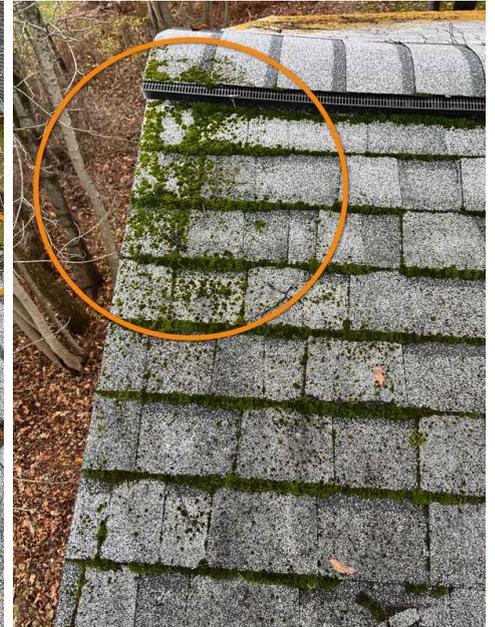
4.1.1 Coverings

VEGETATION / MOSS / ETC.

ROOF

Note presence of moss debris on lower portion of rear side of roof. Also note smaller, minor, areas throughout roofline. Recommend further assessment and evaluation from qualified roofing professional.

Contact a qualified roofing professional.

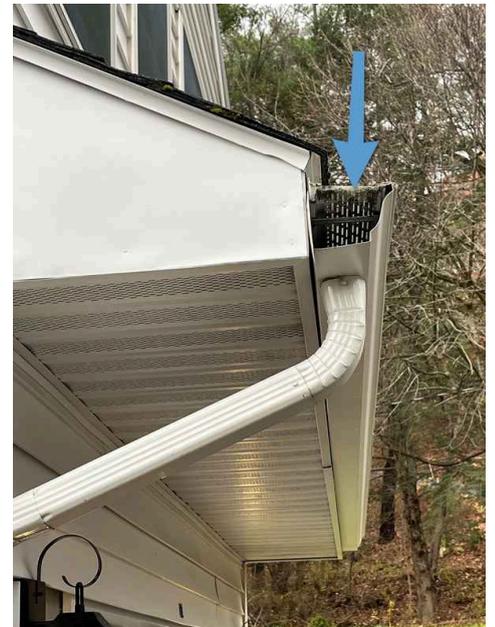
4.2.1 Roof Drainage Systems

GUTTER DAMAGED

GARAGE OVERHEAD

Gutter end cap missing from portion above garage door.

Recommended DIY Project

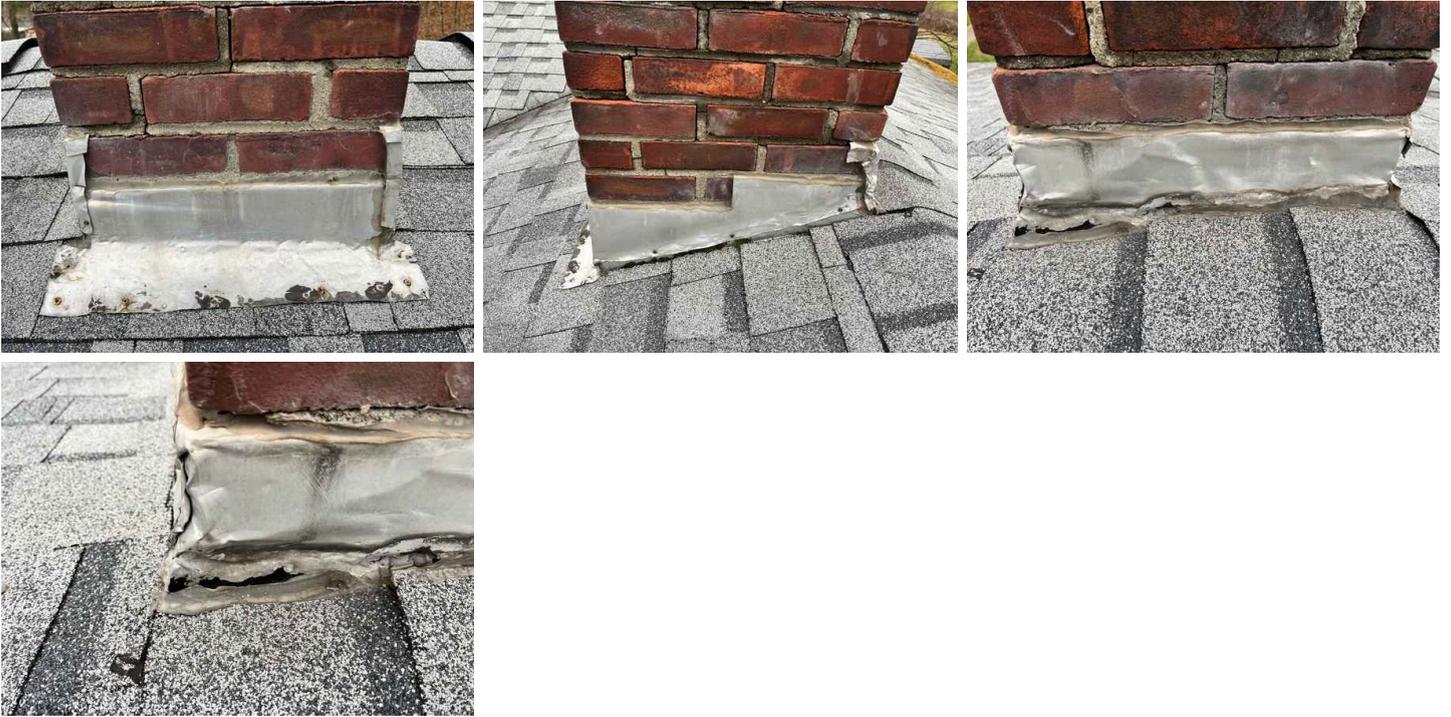
4.3.1 Flashings

CORRODED - MINOR

Roof flashing showed signs of corrosion, but are still in working condition. Flashing should be monitored to prevent severe corrosion leading to moisture intrusion.

Contact a qualified chimney contractor.

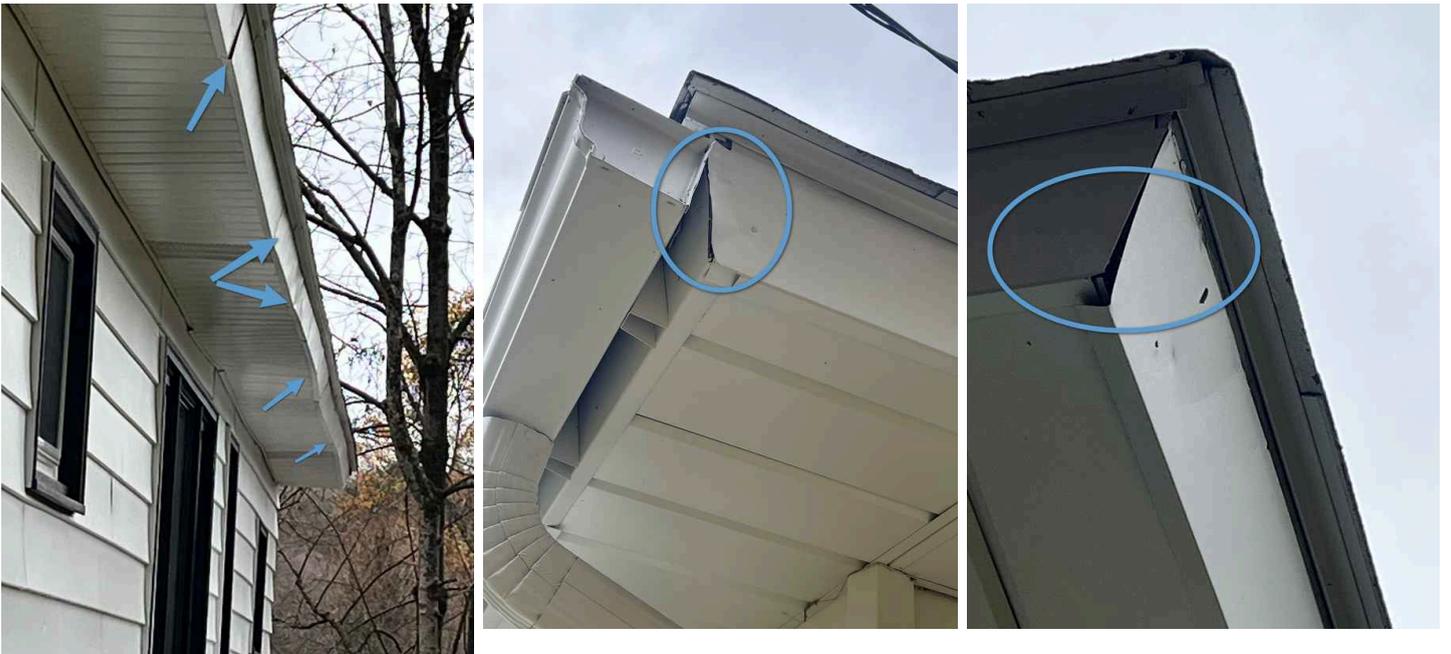
4.3.2 Flashings

LOOSE/SEPARATED

EAVE / SOFFIT AREA

Flashings observed to be loose or separated, which can lead to water and/or insect intrusion which could lead to deterioration and / or mold and mildew. Recommend a qualified roofing or siding contractor repair.

Contact a qualified roofing professional.

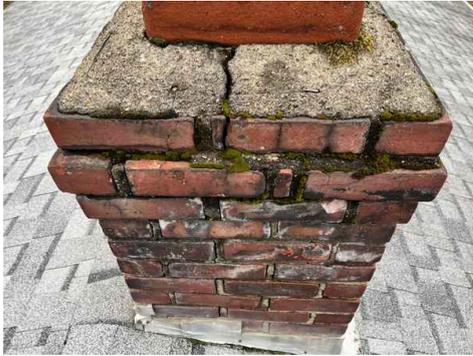
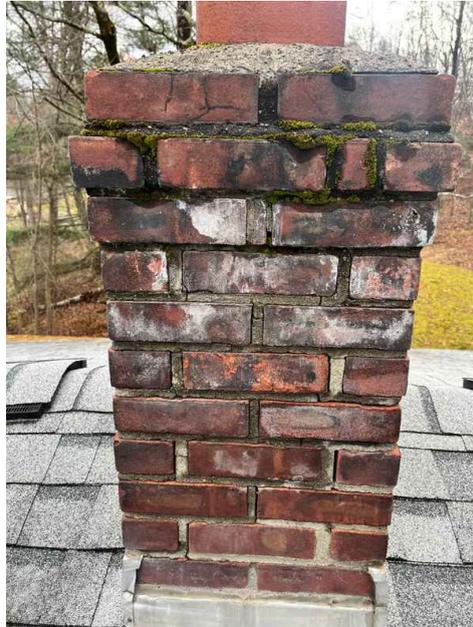
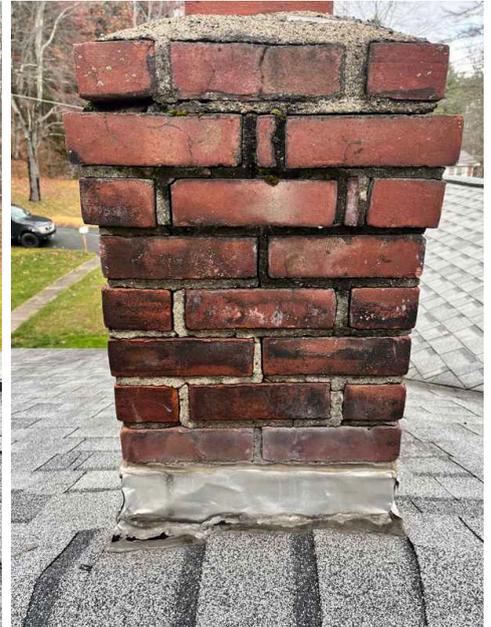
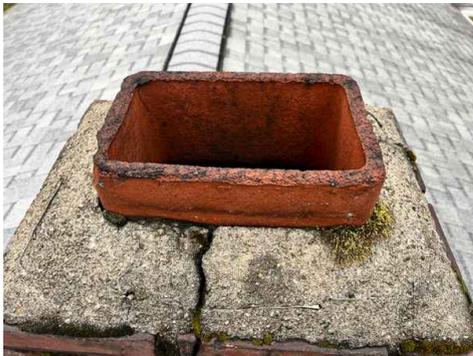
4.4.1 Skylights, Chimneys & Other Roof Penetrations

CHIMNEY REPOINT

ROOF

Joints in the masonry have deteriorated and should be repointed. (Repointing is the restoration of the mortar joints in the masonry). Recommend client to monitor and, if necessary, be inspected and assessed by qualified chimney contractor.

Contact a qualified chimney contractor.

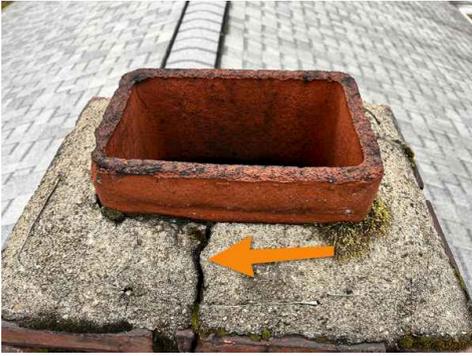
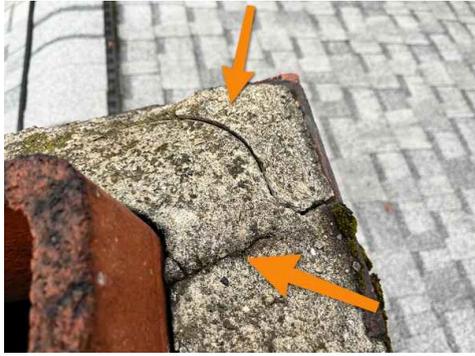
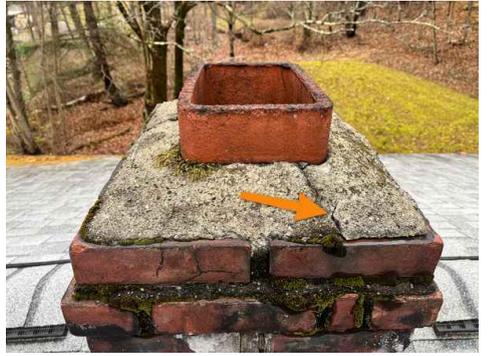
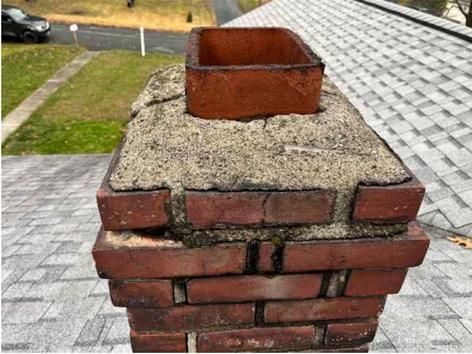
4.4.2 Skylights, Chimneys & Other Roof Penetrations

MORTAR CRACKED, MISSING PIECES, ETC.

CHIMNEY

Note cracked mortar portions at chimney flue cap trim. Recommend inspection and assessment from a qualified chimney contractor.

Contact a qualified chimney contractor.

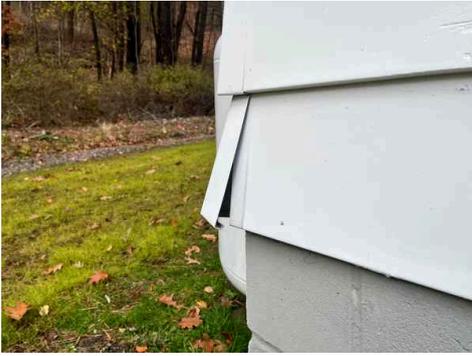
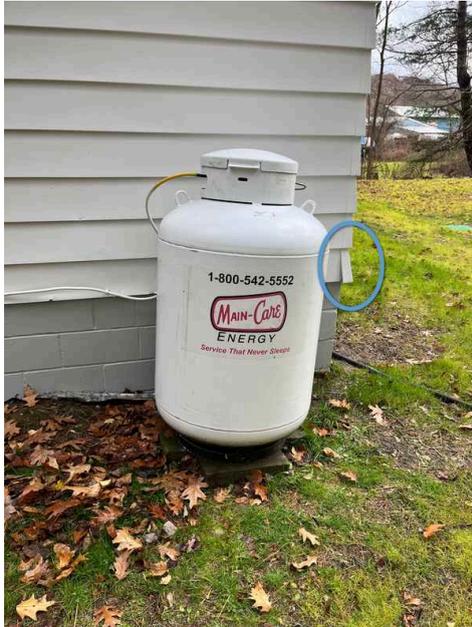
5.1.1 Exterior Siding

DAMAGED / MISSING

EXTERIOR

Lower corner cap portion siding is loose.

Recommended DIY Project

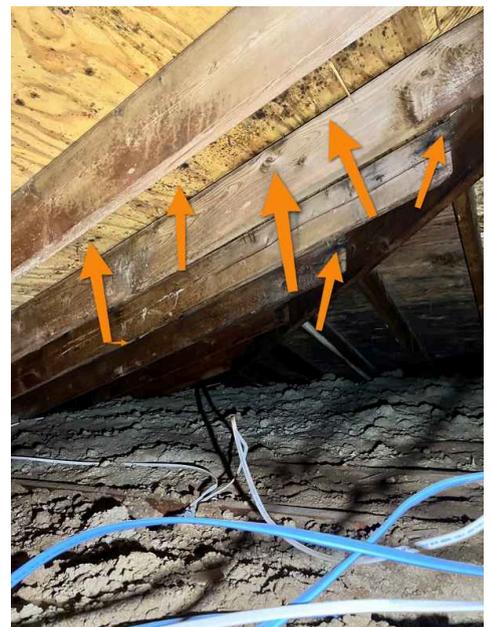
6.2.1 Ventilation

DISCOLORATION - POSSIBLE MOLD

ATTIC

Attic showed areas of discoloration and possible mold growth. Recommend a mold lab analysis to prevent spread of potential mold and damage to home or health risk.

Contact a qualified mold inspection professional.

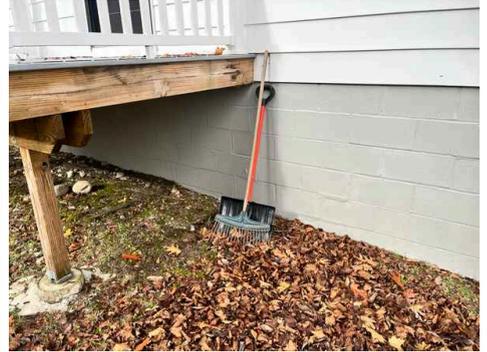
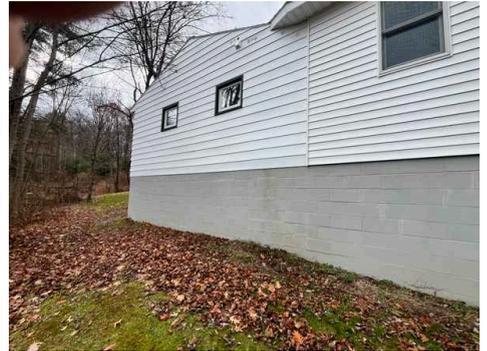
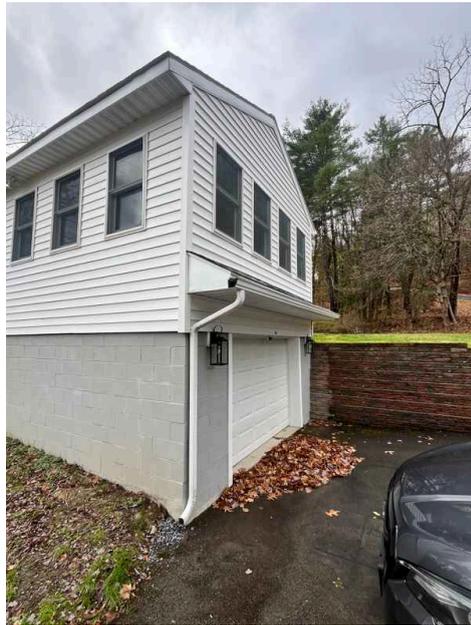
Evidence of recent repair upgrades to foundation exterior and interior. Noite slight efflorescence form moisture intrusion however No defects notes at time of inspection. No evidence of water intrusion and / or flooding.

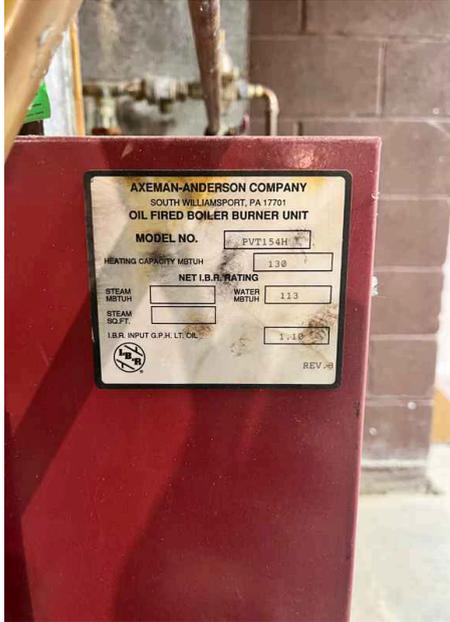
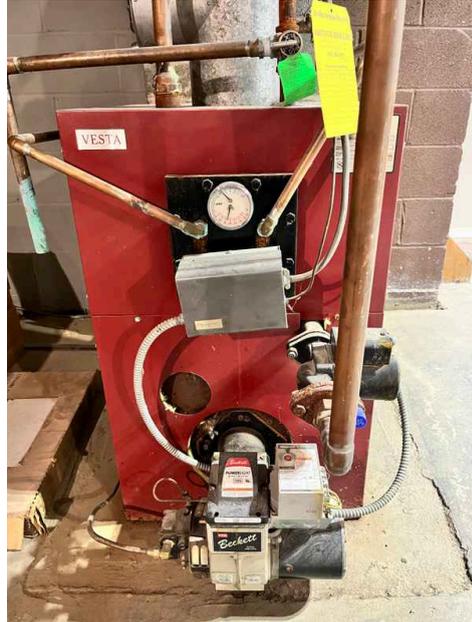
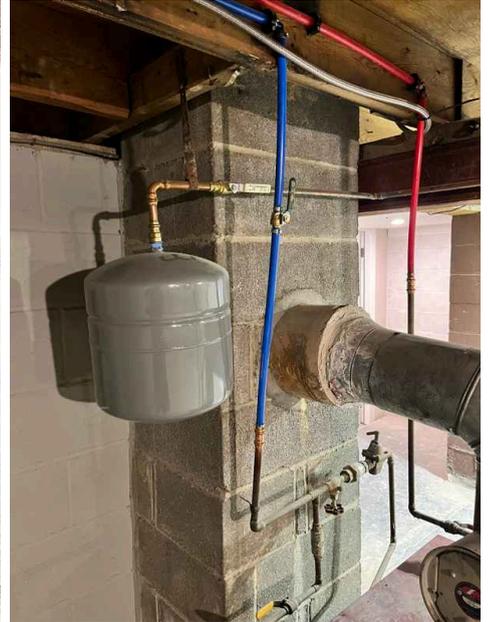
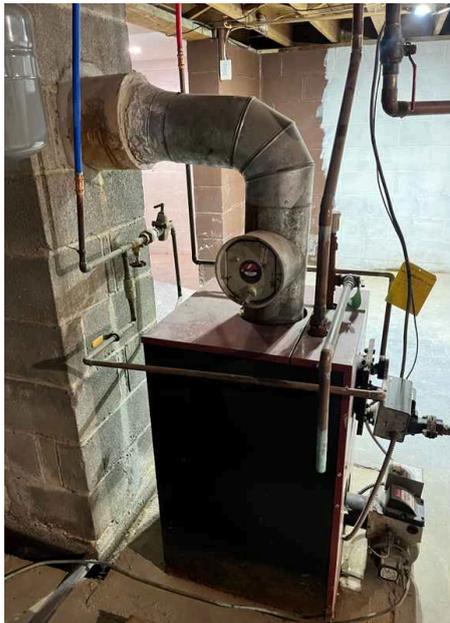
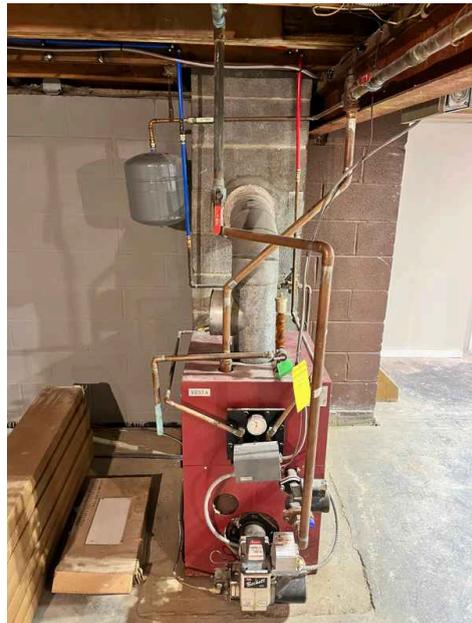
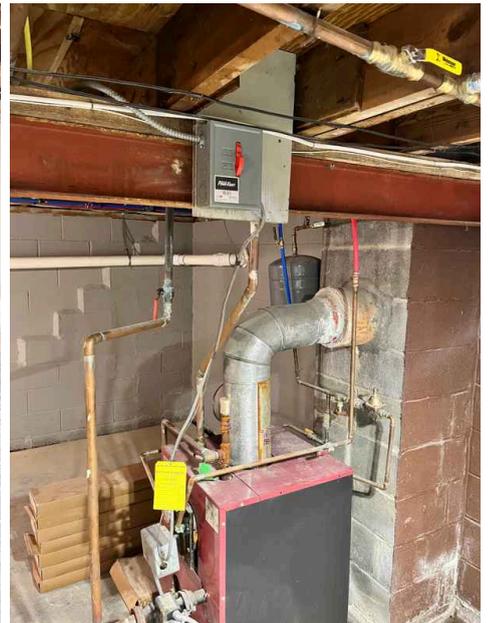
Age Unknown (estimated age 10-15 yrs old) Axeman-Anderson boiler units have been manufacturing since the 1940's. Evidence of recent repair upgrades. No signs of leakage, corrosion , or malfunction. Verify boiler operation and satisfy operated via wall mount thermostat.

Recommend further investigation, boiler inspection and adjacent plumbing service from qualified plumbing / heating contractor (confirmed with client as to options).

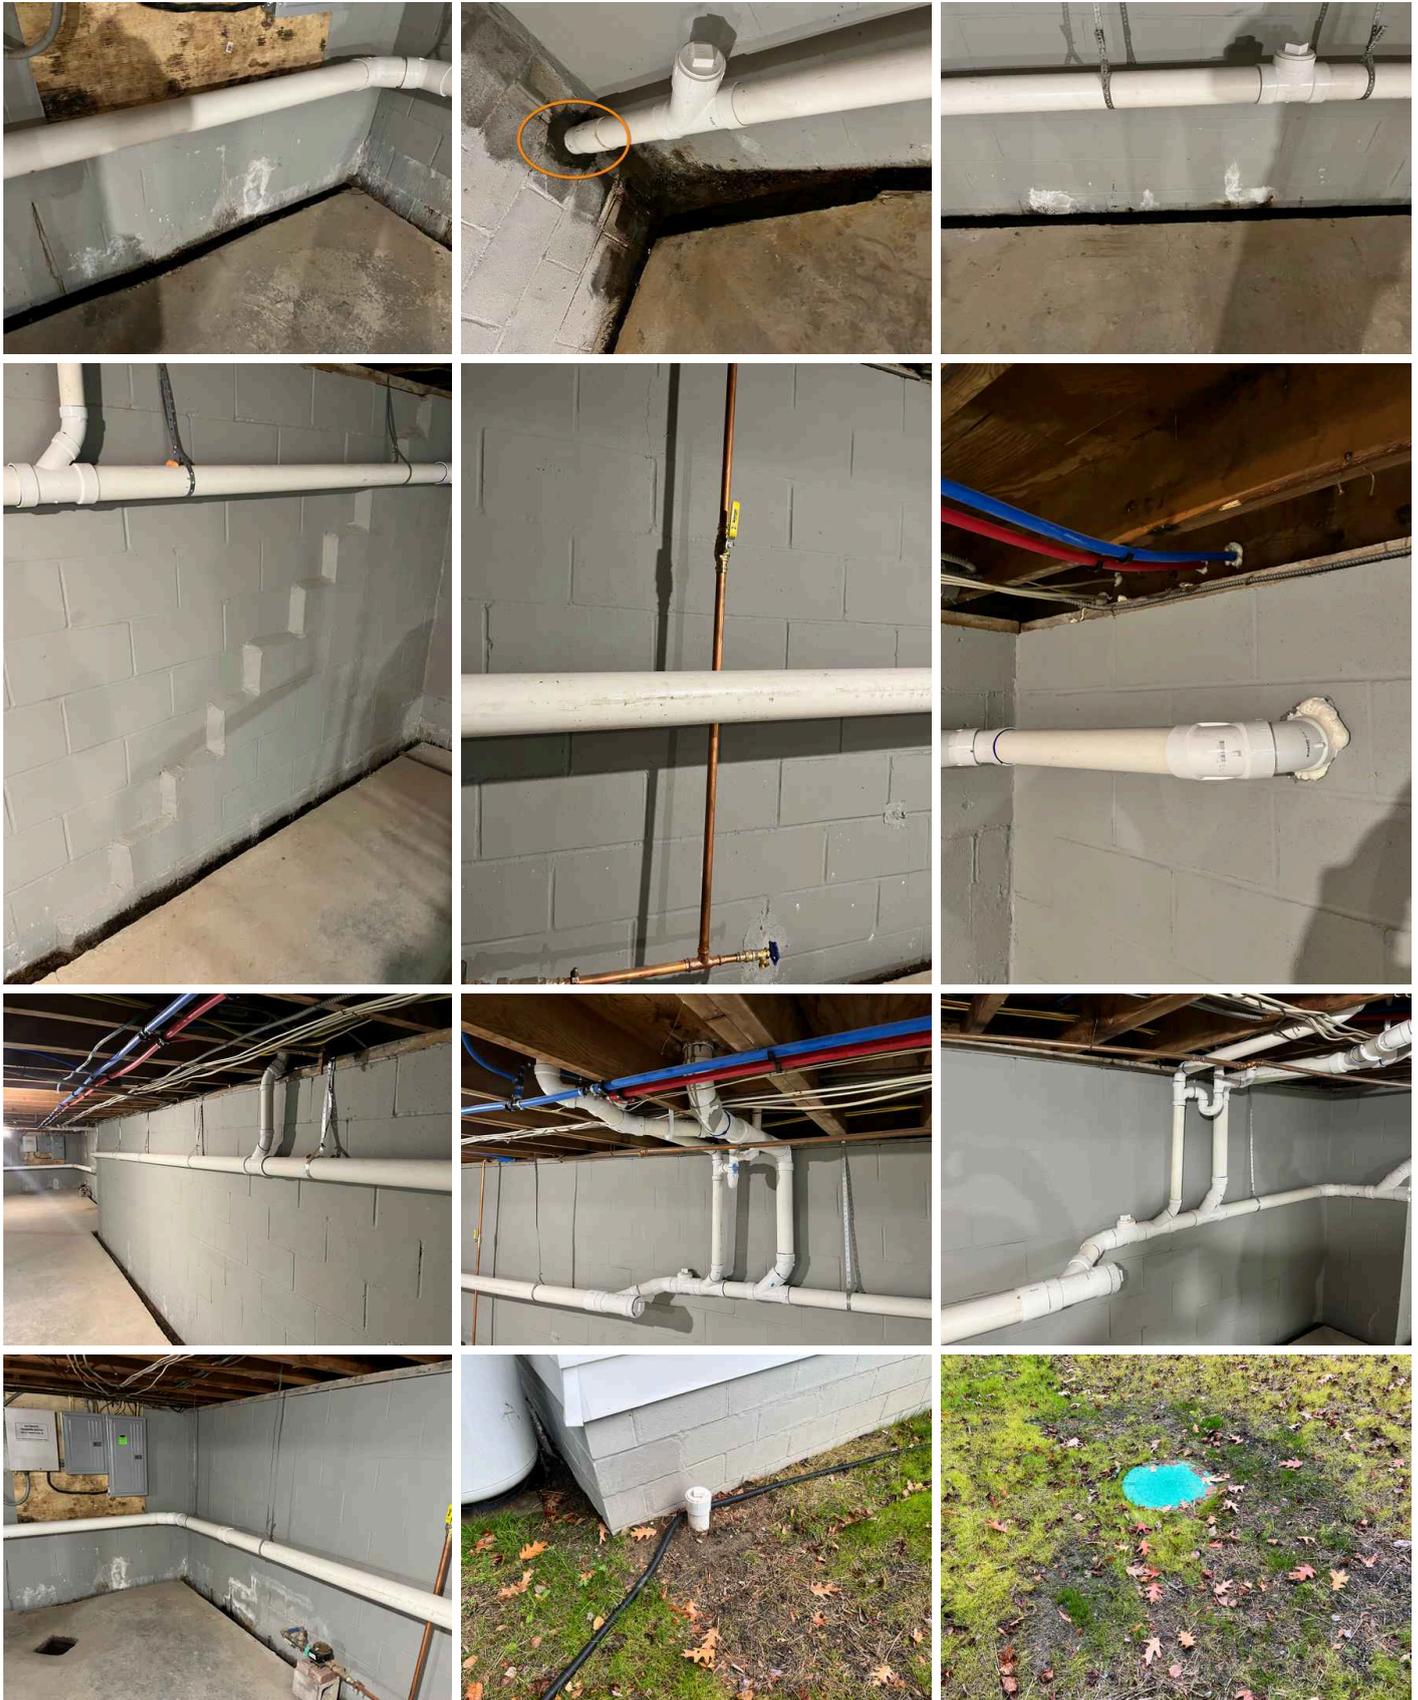
It appears that the Main DWV (drain, waste, vent) system and piping has been recently replaced. Note presence of new 3" PVC piping into basement with what appears to be foundation repairs from main waste drain pipe to septic tank replacement. Note no information as to when this system ,tank, and components were replaced.

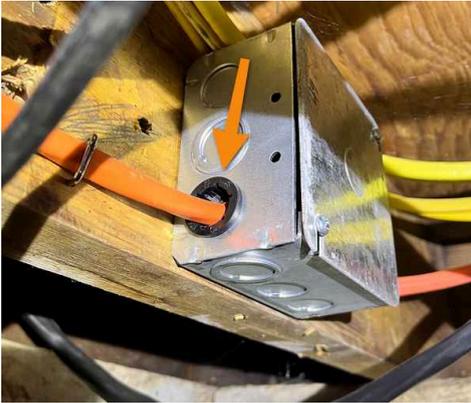
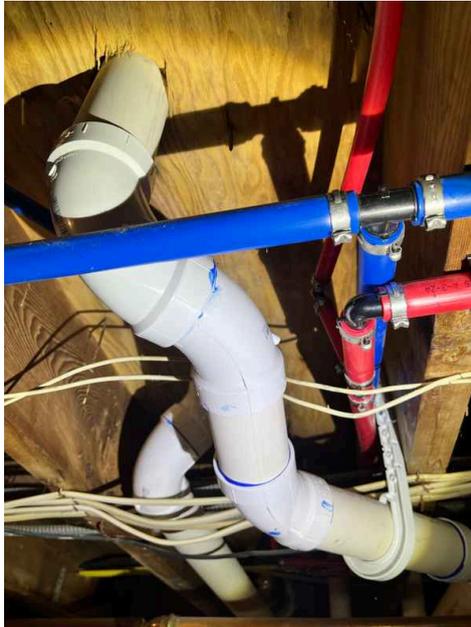
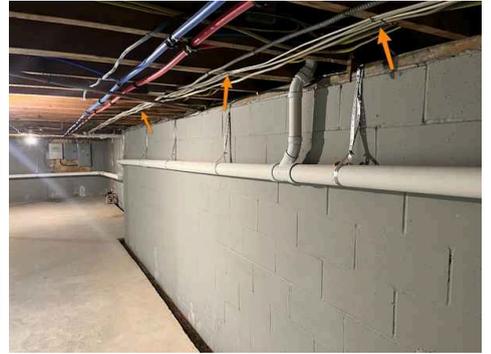
19.3.1 Branch Wiring Circuits, Breakers & Fuses

Note no Romex connector securing 10 gauge branch supply into junction box. Recommend further inspection from a qualified electrical contractor.

Contact a qualified electrical contractor.

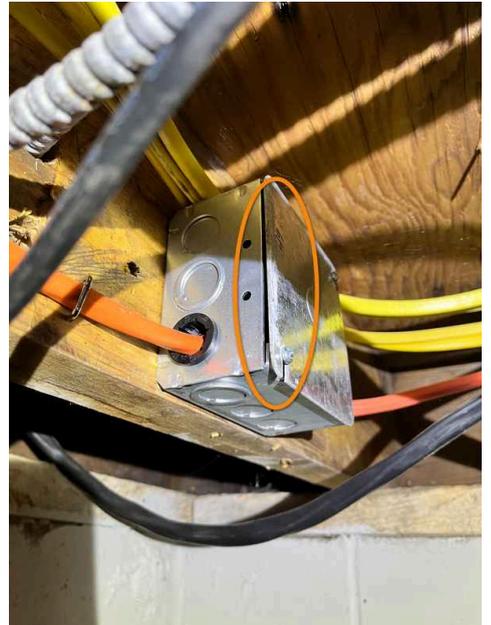
19.3.2 Branch Wiring Circuits, Breakers & Fuses

UNSECURED / UNCOVERED / LOOSE MOUNTING FIXTURES

Noted loose cover for junction box.
